# Improving Surface Imperfection

Learn how our Material Support & Solutions team solved this customer material issue.

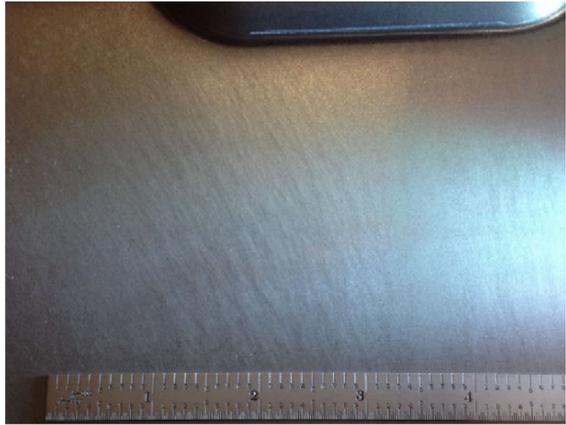
The customer was experiencing occurrences of surface ripples on drawn components. The problem was sporadic across different lots and could not be detected until after forming.

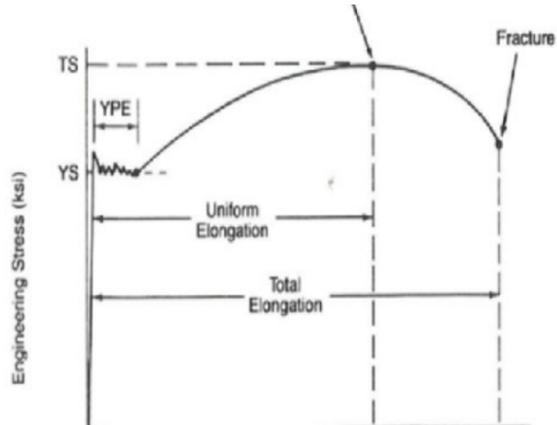
The ripples were a result of Luders lines (stretcher strains), which are a result of discontinuous yielding. Defective material was analyzed and compared with successful material. Processing paths were the same, but defective material showed higher levels of yield point elongation (YPE).
