# Diagnosing Material Behavior

Learn how our Material Support & Solutions team solved this customer material issue.

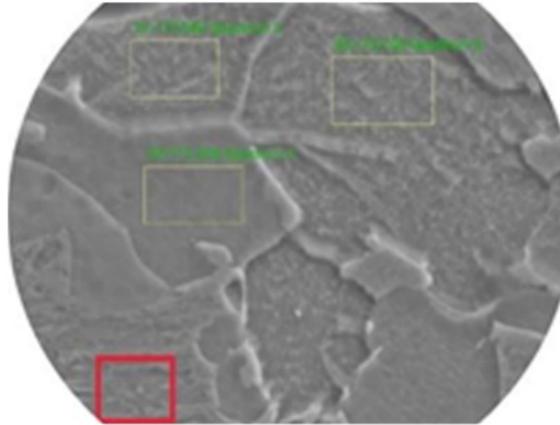
Our Technical Service Laboratory performed a detailed metallurgical investigation. Using scanning electron microscopy, optical microscopy, and hardness testing, the team identified a microstructural cause within the steel that had not dissolved during the heat treatment process further downstream.

In partnership with the supplier, Worthington refined hot strip mill processing conditions to improve the steel microstructural uniformity. The revised material was validated through laboratory testing and confirmed in full scale production trials. This allowed for restored product performance and reduced delays in processing.
